THE PROCESS OF MUSEIFICATION OF HISTORICAL SITES IN UZBEKISTAN (ON
THE EXAMPLE OF THE MUSEUM OF FAYZULLA KHODJAEV IN BUKHARA)

Ziyaeva Rano Alimjanova

Employee of the State Museum
of History of Uzbekistan

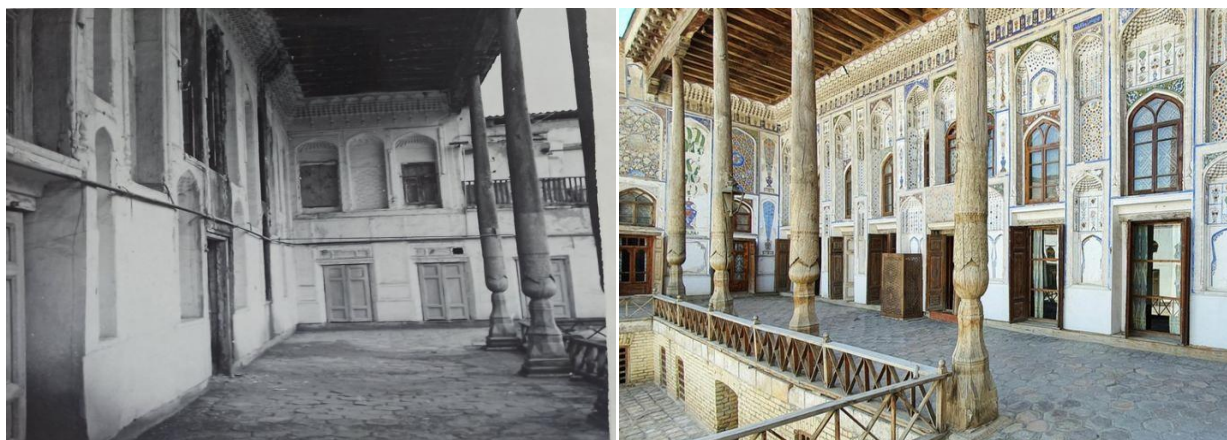
In 1979, the building was taken for restoration by the Ministry of Culture of Uzbekistan, under the supervision of the Special Uzbek Scientific Restoration Workshop and architect Kim V.V. They carried out various works to address the issues mentioned above. Their goal was to preserve the original appearance of the building as much as possible. During the restoration process, lightweight construction materials such as expanded clay and slag concrete were used. To enhance the efficiency of the work, the main layout of the house, several architectural drawings, engineering approaches, and smaller architectural sections were taken into consideration while conducting the restoration[2.40]. In the restoration project, the communicative aspect was also a priority, as the building needed to be connected to the urban infrastructure. The installation of sewage, hot and cold water networks, electricity, gas, and heating systems — everything necessary for a residential building—was carried out. One of the most important tasks for the restorers was to preserve and showcase the building's original appearance. Therefore, they first removed the old, restored plaster and replaced it with new plaster that matched the original. They also attempted to partially restore the decoration by reapplying the patterns that had faded over time [2.40].

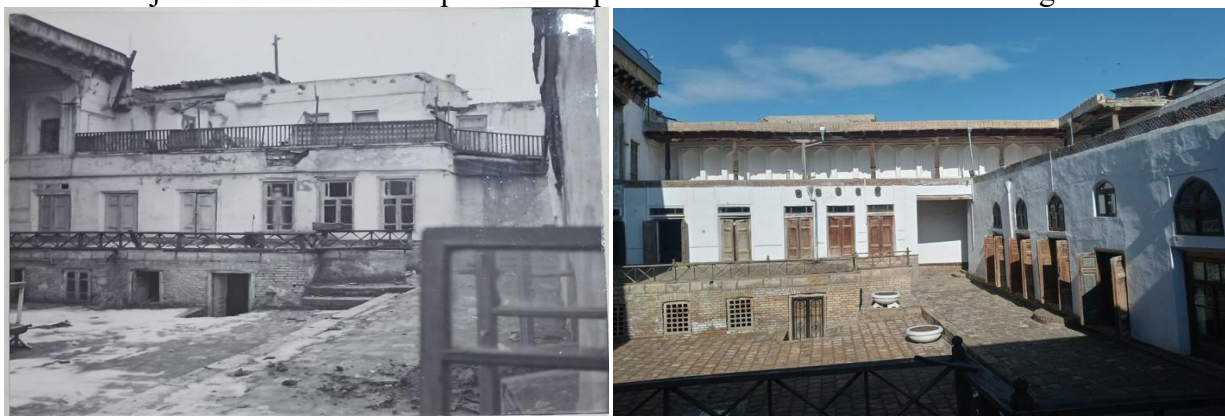
The house, according to the Uzbek architectural traditions of the last century, has two courtyards: the first courtyard – "birun" (outer courtyard) and the second courtyard – "darun" (inner courtyard). The first part of the courtyard – "birun" – no longer retains its decorative elements. However, the second part of the courtyard – "darun" – has preserved its decorative elements, including craftsmanship, sculpture, carving, monumental painting, and woodwork, which adorn the interior and the courtyard facades [3.10].

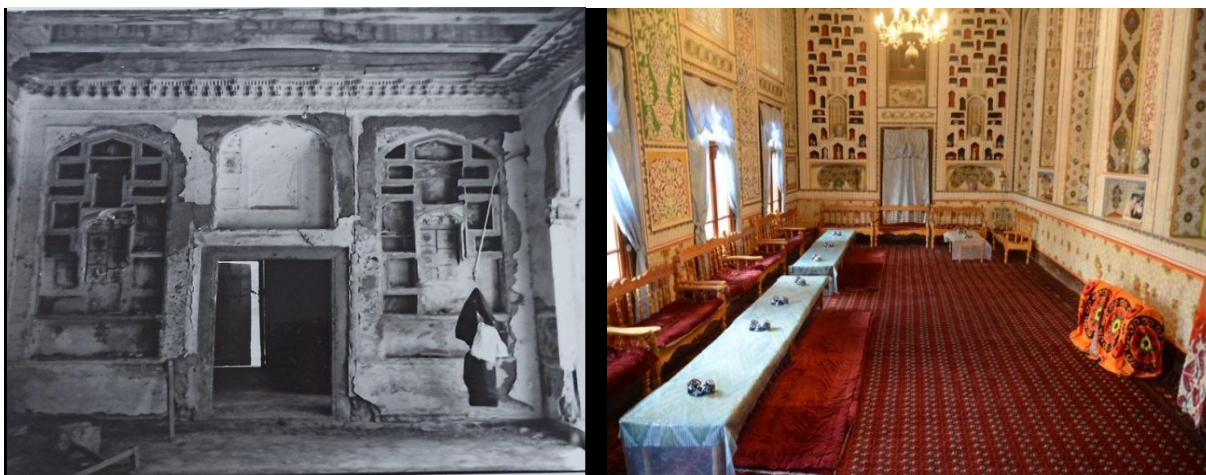
in the multi-level partitioning of the walls, which are decorated with geometric patterns (girikh) made of plaster, the partitions adorned with floral motifs (gulcha), and the wall niches. The walls also feature horizontal divisions that, together with the vertical partitions, visually expand the size of the rooms. The dimensions of the decorative patterns are also characteristic, and they are drawn in a manner that perfectly suits the shape and proportions of the rooms. In smaller rooms, the panels and niches are divided into smaller sections, filled with pictures or additional decorative elements. The wall niches and the semi-domes of the cornices are decorated with small muqarnas. In the larger rooms, the niches and panels have solid mirrors and are filled with large plaster carvings and patterns. The semi-dome and cornice parts of the niches are covered with larger muqarnas. It is evident that larger decorations were used in the bigger rooms, while smaller decorations were applied in the smaller rooms. The vertical division of the rooms in the larger spaces with panels and their cohesive decoration gives the rooms a grand and ceremonial appearance. Various decorative techniques were used to adorn Fayzulla Khodjaev's house. For instance, majestic paintings were drawn on flat surfaces in the "edirma" style. The plaster carvings and muqarnas also featured patterns. The patterns primarily included flowers in the "Munobati Gulzor" vase, small flowers in the "gulcha" style, and decorative motifs like "majuntol," all expressed in soft, subdued colors.

The plaster carvings are expressed on flat surfaces with floral and geometric decorations. These decorations are also reflected in the patterns on the ventilating shutters and the niches. In the plaster carving technique, the "qirma" style was used, while the "iroqi" and "muqarnas" styles were widely applied in the muqarnas.
