## **STRATEGIES FOR ENHANCING ENERGY EFFICIENCY IN BUILDINGS AND FACILITIES**

**Abstract:** This article examines the current state of energy consumption at an industrial enterprise, including electricity, heat, gas, fuels and lubricants, as well as ventilation and compressed air systems, buildings and structures, technological equipment, and auxiliary systems. It identifies existing technical and commercial losses, develops energy balance sheets, evaluates the efficiency of resource utilization, and proposes economically justified technical solutions for energy conservation.

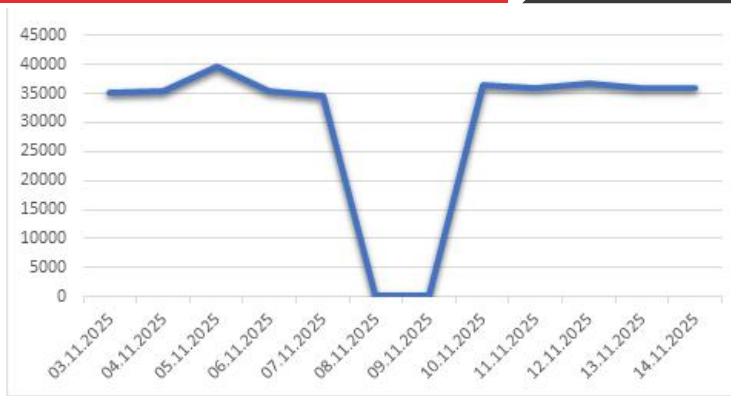
**Graph 1. Electricity consumption 3-14.11.2025**

According to the daily consumption schedule, the main load was formed in the period from 09.00 to 18.00. During this period, consumption was in the range of 4300–4650 Wh, and the maximum load was recorded in the period from 12.00 to 13.00. Between 13.00 and 14.00, a short-term decrease was observed due to the lunch break. Starting from 19.00, the load decreased sharply, and between 01.00 and 06.00, the minimum network load was recorded in the range of 100–150 Wh. The total electricity consumption for 24 hours was 35177 Wh. This result confirms that the current production cycle of the enterprise consists only of day shift operations. The monthly analysis examined the consumption dynamics for the period from November 3 to 14. Daily consumption on weekdays ranged from 34,690 to 39,500 Wh. The highest consumption was recorded on November 5, 2025 at 39,500 Wh. Since November 8–9 were weekends, consumption decreased sharply, reaching 200 Wh and 150 Wh, respectively. On November 10–14, against the backdrop of the resumption of production, the electrical load returned to normal levels and was in the range of 35,900–36,800 Wh. These data indicate that the production process at the enterprise operates actively in the usual mode only on weekdays, and on weekends, energy consumption drops to a minimum.
