MAKING CHANGES TO THE DASHBOARD OF A COBALT CAR

D.A. Moydinov

S.O. Sultonov

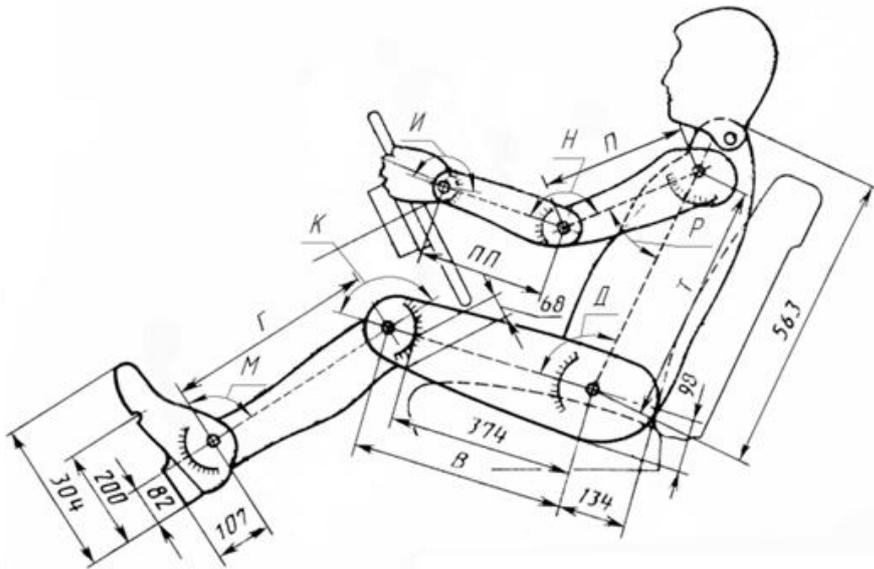
The design of the driver's workplace is carried out in accordance with the standards specified in GOST 37.001.413-86. During the design process, a two-dimensional mannequin, based on GOST 20304-85, is used to simulate the postures of drivers of varying body types. The templates consist of major body parts including the head, arms, and legs (Figure 1). Angular rulers are installed for setting and measuring the angles between axes of these elements. A measuring device is attached to the torso component to set and determine the angle between the body axis and vertical axis [1].

Figure 1. Two-dimensional mannequin

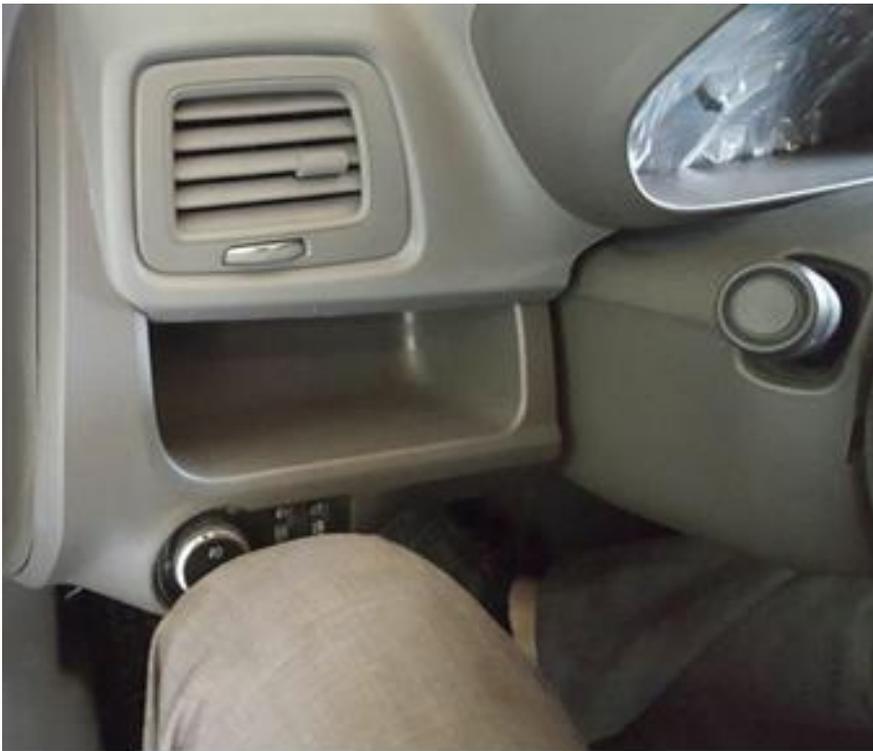
Figure 2. Current Layout of the Cobalt Instrument Panel

Unlike in the Cobalt, similar components in Genra and Nexia 3 are positioned higher, causing no interference. As seen in Figure 2, there is sufficient space above the current location of the lighting lever in the Cobalt, measuring approximately 18 cm in width and 5–6 cm in height. Half of this space is adequate for repositioning the lever, similar to the layout in the Spark model. This space is typically unused, as placing other items there is impractical due to vibration-related inconvenience. Therefore, relocating the control lever to this area is feasible.

When analyzing the lighting control lever of the Chevrolet Cobalt, it has been observed that during driver entry, the driver's knee may contact the lighting adjustment lever, leading to mechanical damage or breakage. While this may not pose a significant issue during daylight hours, it can create a serious safety risk at night. If external light indicators also fail, the risk of accidents increases significantly. A broken lighting lever also disables the vehicle's side lights, license plate illumination, and dashboard backlighting. Malfunctioning tail lights pose a danger to drivers approaching from behind. Replacing the damaged part requires time and resources—an average of 250,000 UZS per repair. Moreover, this problem tends to recur over time, making it a persistent issue.

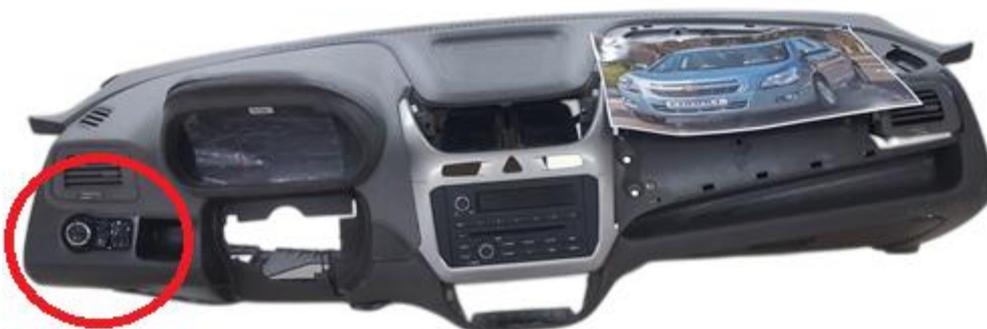
Figure 3. Modified Layout of the Cobalt Instrument Panel

relocate the lever to the upper section of the instrument panel was developed. This solution is supported by comparisons with the layouts of similar models such as Genra, Nexia 3, and Spark, and is grounded in practical application. The proposed new layout enhances component safety, improves ergonomic comfort for the driver, and does not interfere with other vehicle systems while maintaining aesthetic integrity. Research findings indicate that the new location of the lighting control lever increases overall usability, reduces maintenance costs, and eliminates discomfort affecting driver health. Thus, the proposed design modification may serve as an important step in improving the ergonomics and technological quality of the Chevrolet Cobalt.
