EROSION PROCESSES ON THE BANKS OF THE PACHKAMAR RESERVOIR

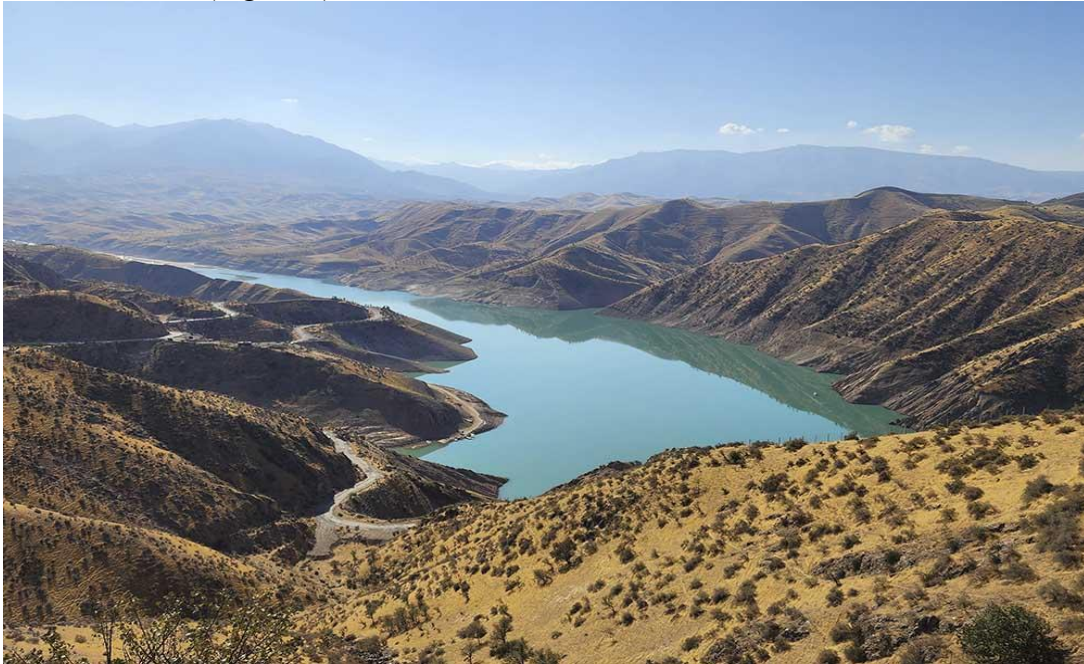
Figure 1. View of the banks of the Pachkamar reservoir.

As a result of a sharp decrease in the level of the reservoir, a residual pressure of water vapor is formed between the coastal soil layers, and as a result of its influence, erosion of the coastal soil, its displacement, landslides and erosion on the banks occur. As a result of the resulting events, the reservoir basin is filled with silt and sediments and the volume of the reservoir decreases. (Figure 1)
